Water Main Break Rates In the USA and Canada: A Comprehensive Study

Steven Folkman
Utah State University

March 2018

An Asset Management Planning Tool for Water Utilities

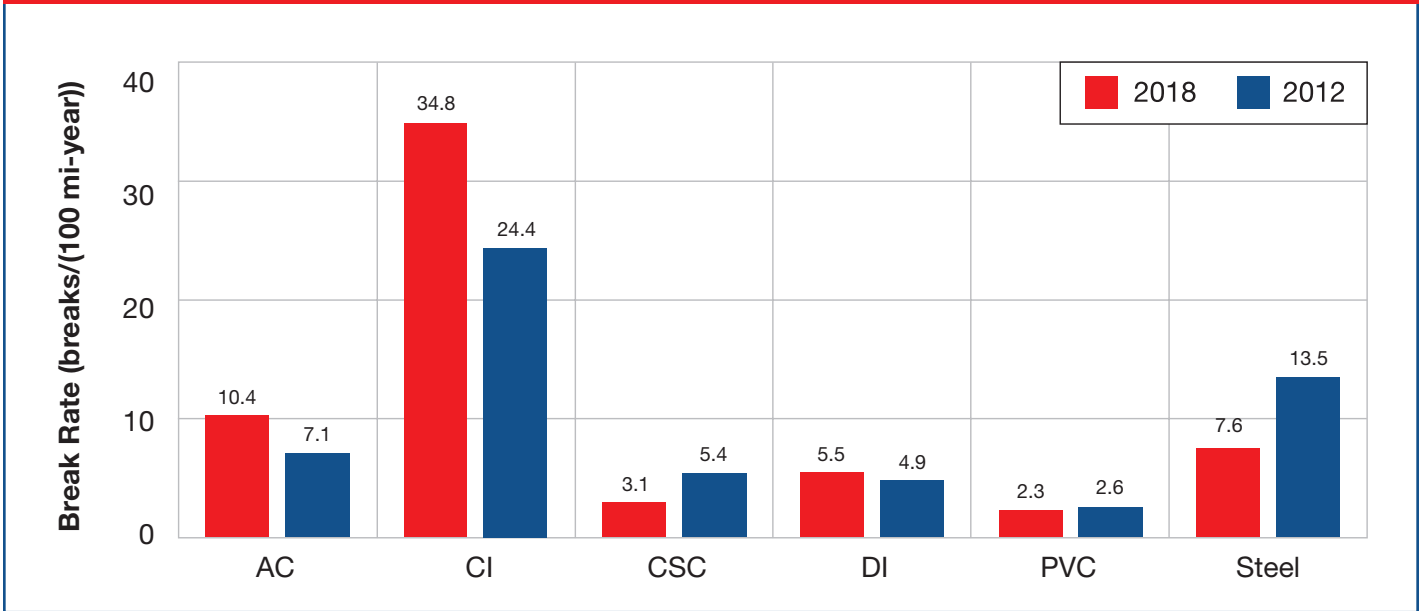
FIGURE 22: COMPARISON OF BREAK RATES OF THE 2018 AND 2012 SURVEYS

Figure 22 compares the break rates of the 2012 and 2018 surveys. Since over 90% of installed pipe consists of AC, CI, DI, and PVC, the break rates for those material types will be most accurate. From 2012 to 2018, Figure 22 shows a small decrease in break rates for PVC and a small increase for DI pipe. The overall consistency of those values demonstrates they are accurate. Again, the increase in break rates for AC and CI pipes is a very significant observation.

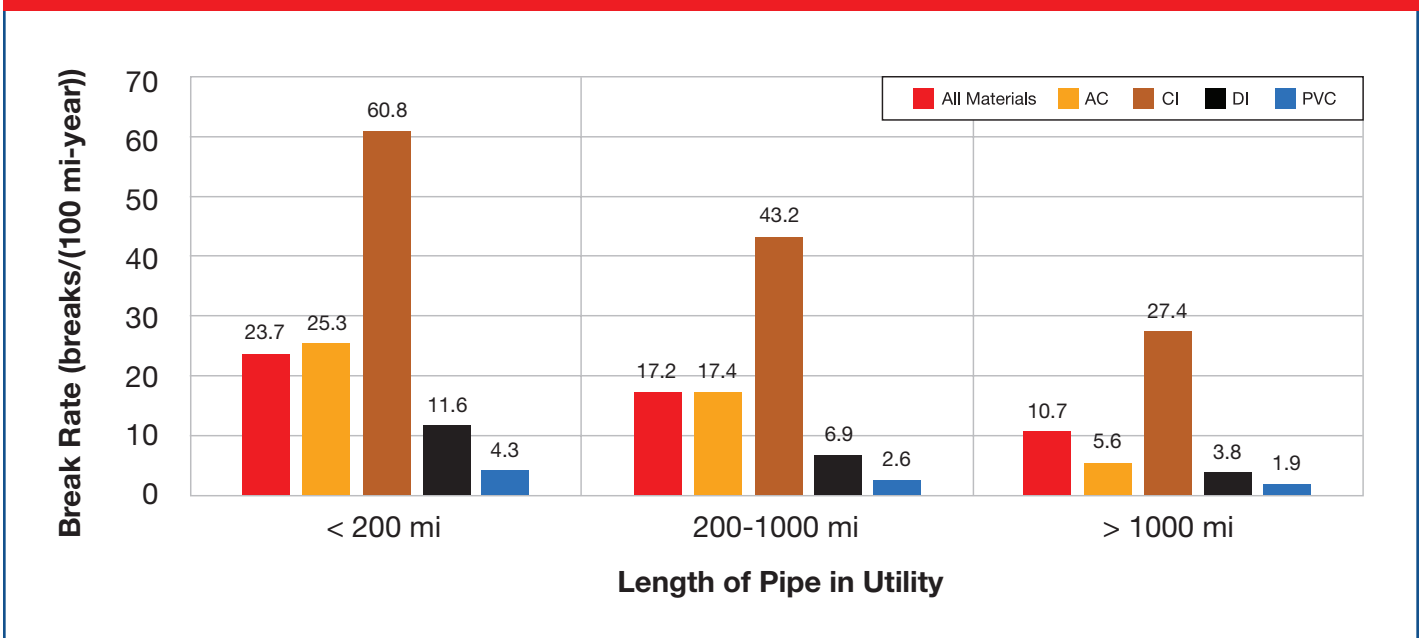
FIGURE 23: BREAK RATES BY UTILITY SIZE FROM THE BASIC SURVEY

The size of a utility can affect break rates. Three sizes of utilities are considered here based on the length of pipe; small with less than 200 miles, intermediate with 200 to 1000 miles, and large with over 1000 miles. Figure 23 illustrates the overall break rate (for all pipe materials) and then separated by the four most common pipe materials in these three utility sizes. The large utilities consistently had lower break rates than intermediate and smaller utilities. This is likely due to better funding and larger staffs for engineering design, monitoring and information gathering, installation oversight, and repair of water mains. It is very significant that small utilities consistently have break rates at least double that of a large utility.

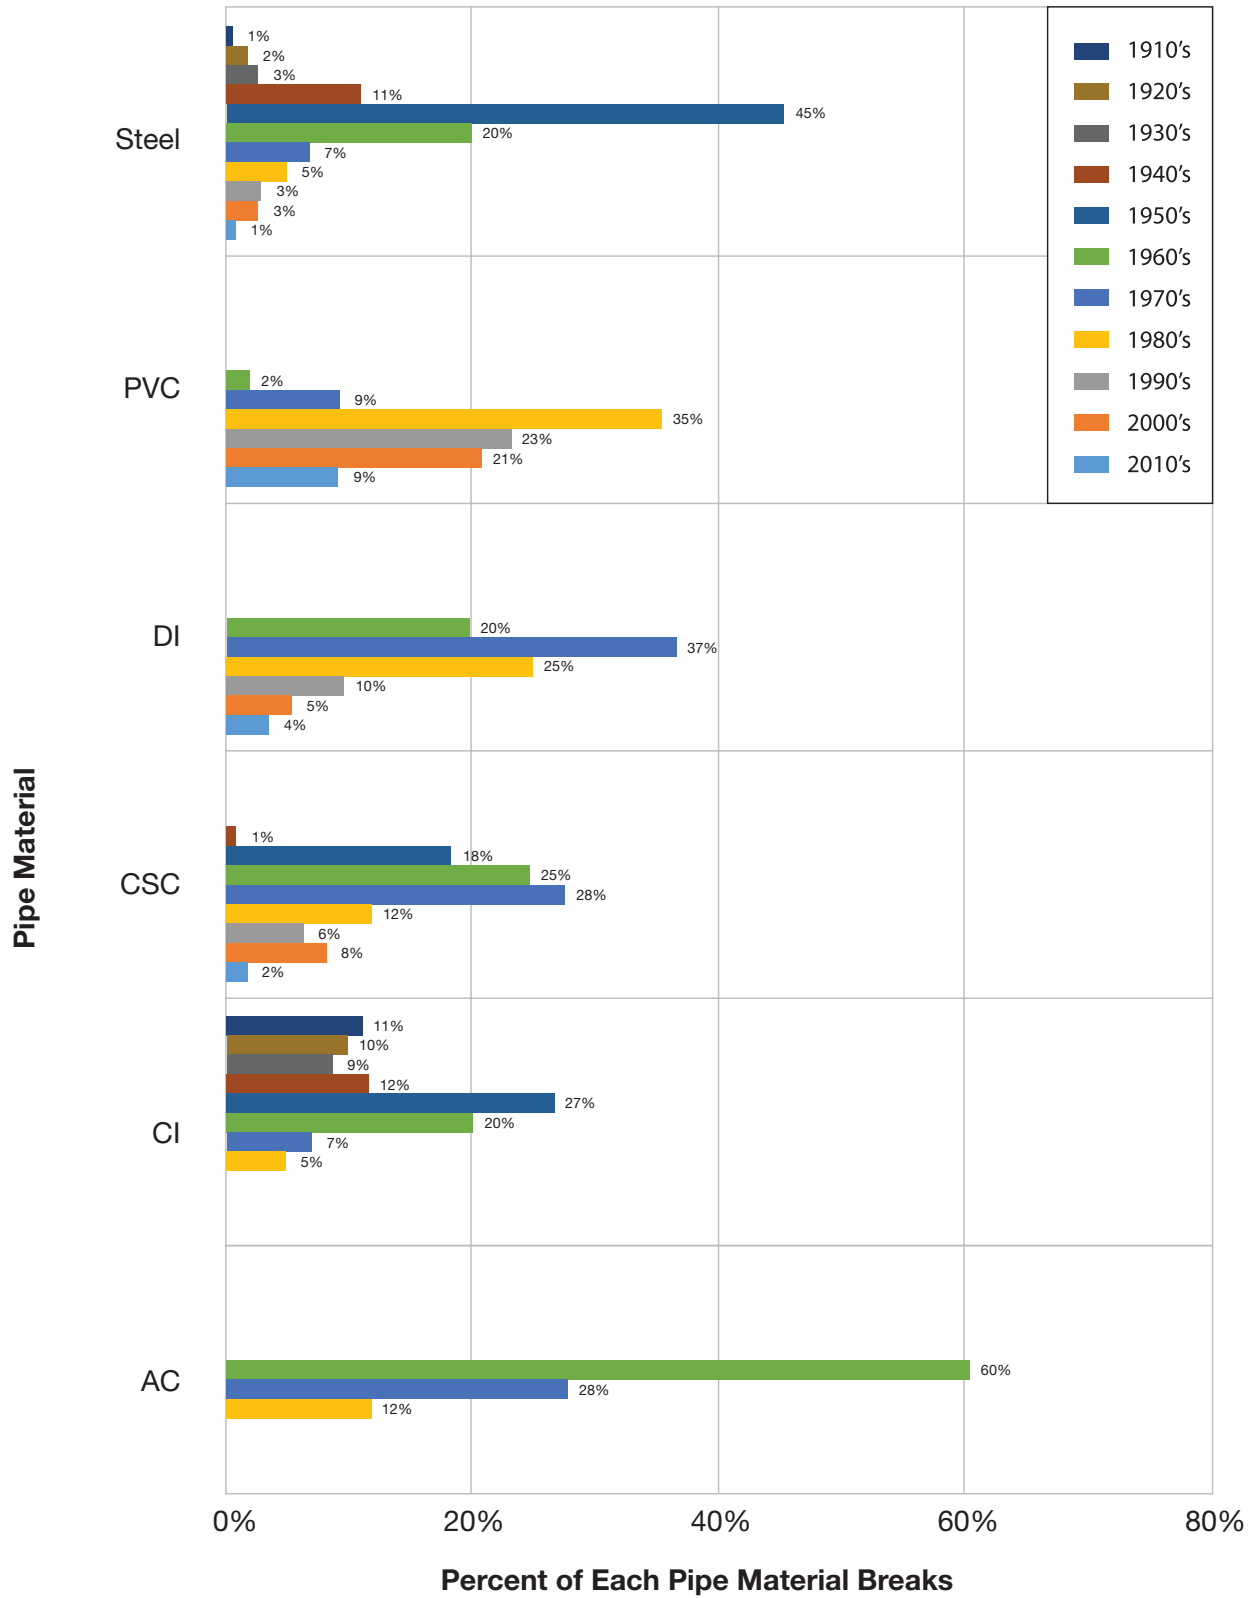
FIGURE 26: PERCENT OF FAILURES PER DECADE OF INSTALLED PIPE MATERIAL

The basic survey asked respondents to break down the failures into the decade when they were installed. Some of the respondents did not know the age of the failed pipes and they were not included in the results. Figure 26 illustrates the percentage of failures of each pipe material based on the decade of installation. For example, asbestos cement (AC) pipe had 60% of the breaks from pipe installed in the 1960's, 28% in the 1970's, and 12% of the breaks in pipes installed in the 1980's. Note that the largest percentage of failures is usually not in the oldest pipes (AC being an exception), which has several possible causes. One important cause is the amount of pipe present in a given age range. As the older pipe is replaced there is less available to fail. Also, cast iron and ductile pipe wall thickness has decreased over the years which can affect time to failure. The results in Figure 26 are also related to when a pipe material was introduced or removed from the market. AC pipe has not been installed in the USA and Canada in the past 25 years, and thus, all AC pipe failures date from the 1980's and earlier. Little cast iron pipe has been installed since the 1980's and that is reflected in Figure 26. Widespread ductile iron and PVC pipe production in the USA did not start until about 1970, so we should expect to see a small failure percentage for both DI and PVC installed in the 1960's and none in the 1950's and earlier.

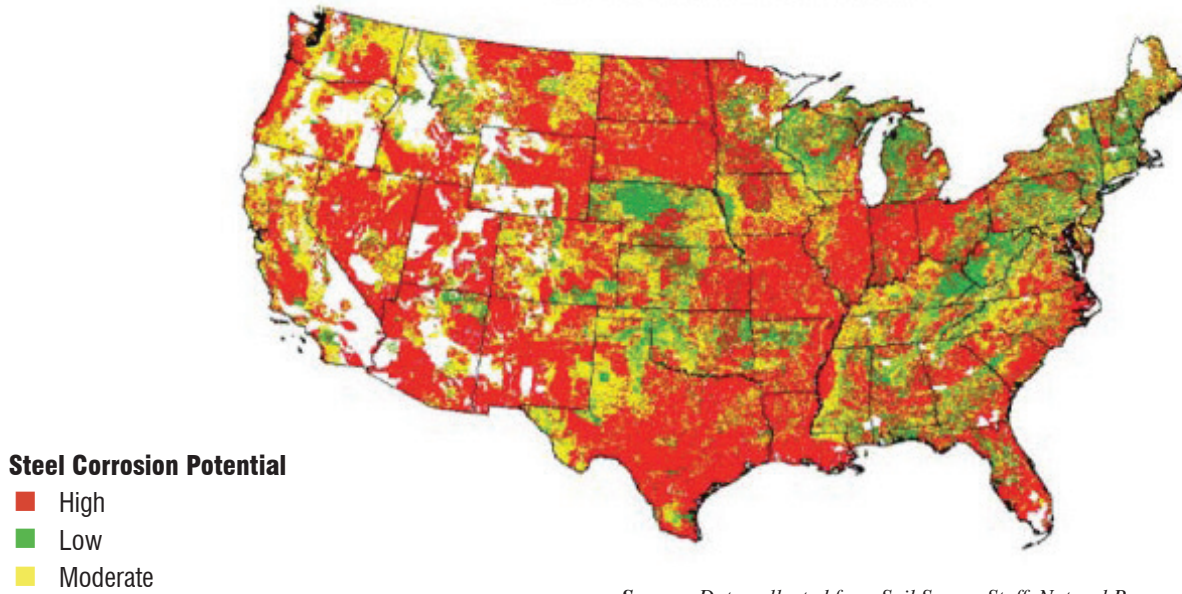
FIGURE 30: US CORROSIVE SOILS MAP (CONUS POTENTIAL FOR STEEL CORROSION)

Source: Data collected from Soil Survey Staff, Natural Resources Conservation Service, U.S. Department of Agriculture Soil Survey Geographic Database.

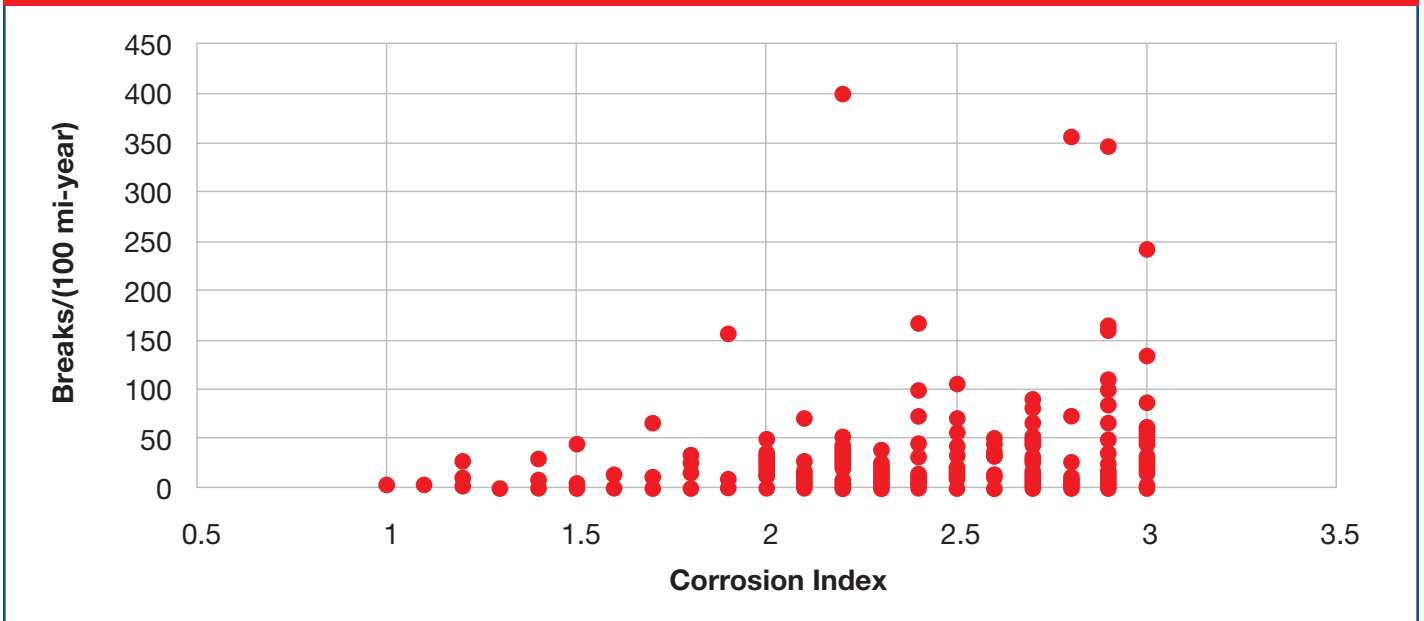
FIGURE 33: INDIVIDUAL UTILITY BREAK RATES FOR CAST IRON PIPE VERSUS THEIR CORROSION INDEX

It is reasonable to expect break rates would increase when pipe is installed in corrosive soils. To examine this, plots were made of a utility's corrosion index versus break rate. Figure 33 illustrates this for cast iron pipe. There is a trend of higher break rates with increasing corrosion index, but the wide scatter in the data makes analysis difficult. The high break rates in Figure 33 are associated with small utilities that have a small amount of pipe. Consider a utility with 1 mile of cast iron pipe with 2 breaks during the past year. That would translate to a break rate of 200 breaks/(100 miles)/year. If that utility had no breaks the following year, the break rates drop to zero.

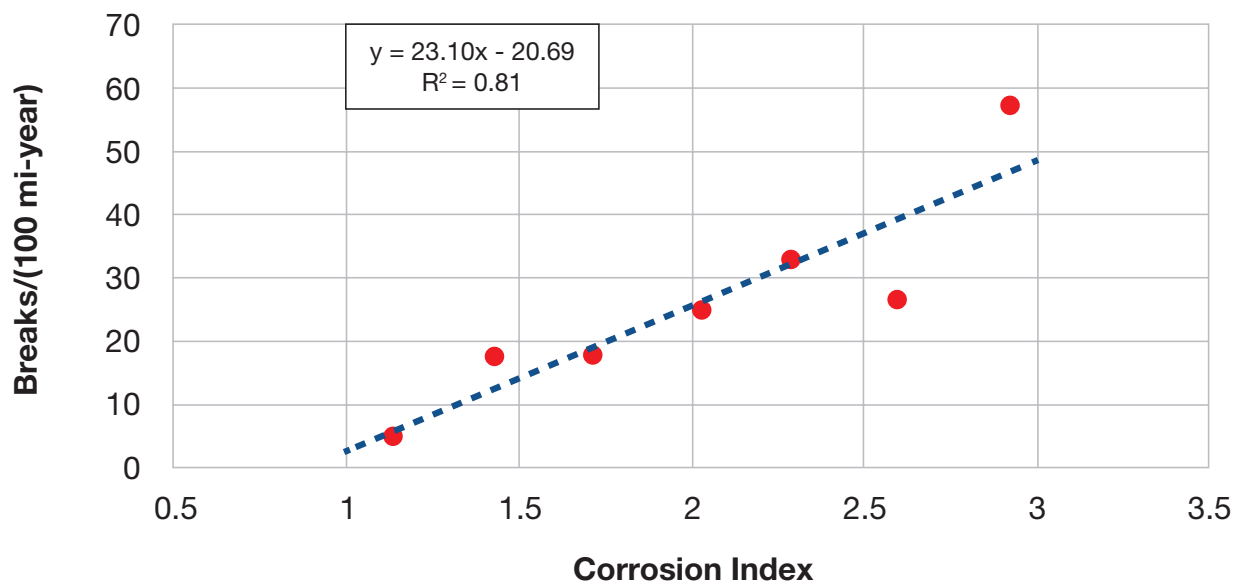
FIGURE 34: CAST IRON PIPE BREAK RATE VERSUS CORROSION INDEX

To get a realistic estimate of break rates, we need to add the number of breaks of a pipe type from several utilities and divide by the sum of the length of that pipe type to compute break rates. The corrosion index data was broken down into the same seven categories used in Figure 32. The results are listed in Table 7. The break rates versus corrosion index data are plotted in Figure 34 for cast iron pipe and Figure 35 for ductile iron pipe. The figures also contain a regression equation fit and a correlation coefficient. Correlation coefficients close to 1.0 indicates an excellent correlation and zero indicate no correlation. Both cast and ductile iron results in reasonably good fits to the data.

Using the equations in Figure 34 with $x=1$ for a low corrosion risk and $x=3$ for a high corrosion risk, one can show that a cast iron pipe in a high corrosion soil is expected to have over 20 times the break rate of one in a low corrosion soil. Similarly, ductile iron pipe in a high corrosion soil has over 10 times the break rate than one in a low corrosion soil. Very poor correlations were found for the other material types in this survey.
